APPENDIX B Urban Road Safety Audit Photographs

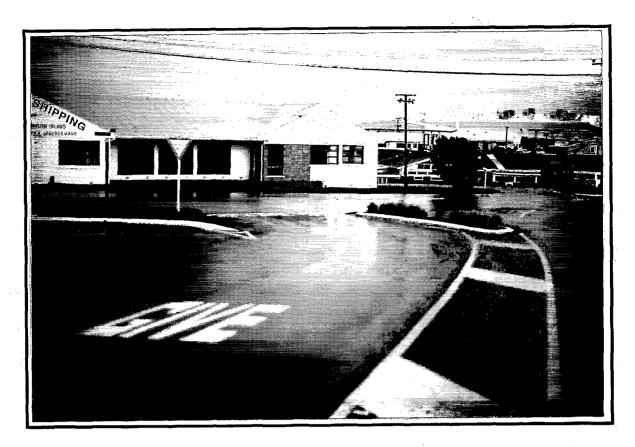
Photograph B1 Poor traffic island conspicuity due to the lack of appropriate warning signs.

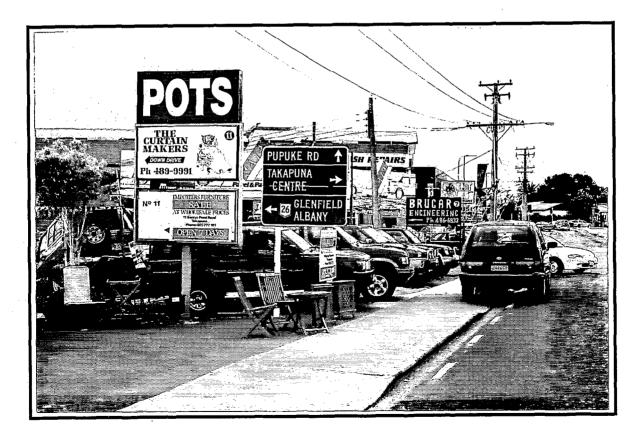
Photograph B2 Over abundance of advertising signs distracts drivers from road signs.

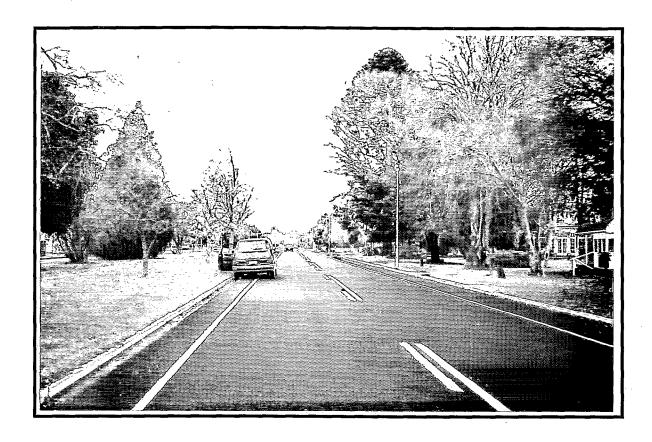
Photograph B3 Lack of appropriate parking width, however, there are no yellow no stopping lines restricting vehicles from parking at the kerbside.

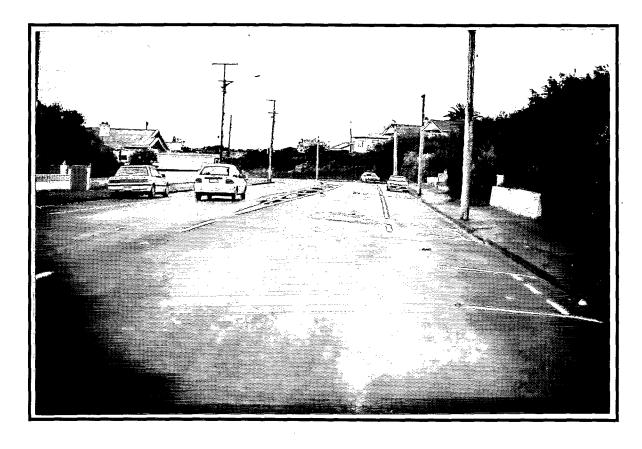
Photograph B4 Abrupt termination of an edge line at the end of a section of road which has been recently marked with a flush median / edge line treatment.

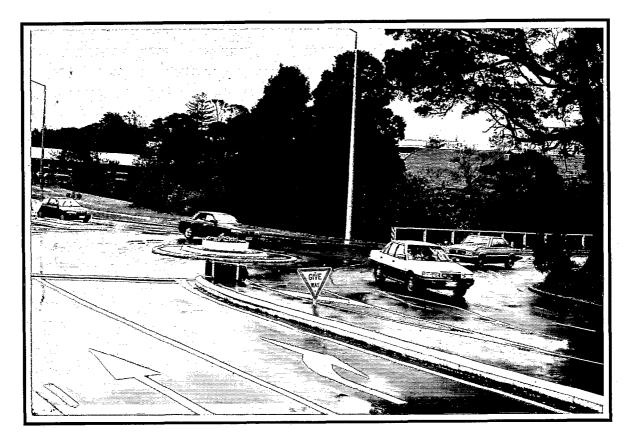
Photograph B6 Small roundabout with no delineation provided by way of warning signs.

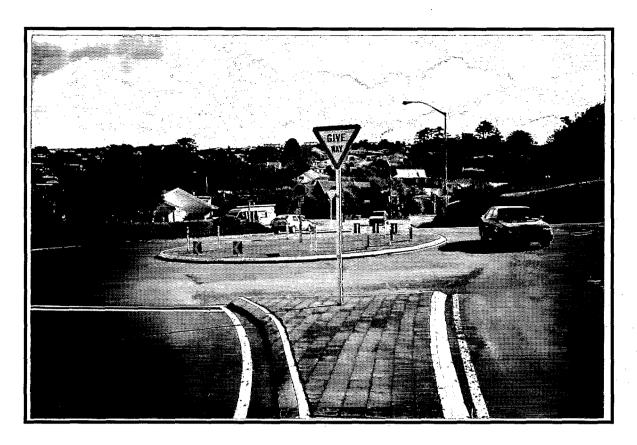
Photograph B7 Use of single curve indicator boards to provide delineation of a smaller roundabout.

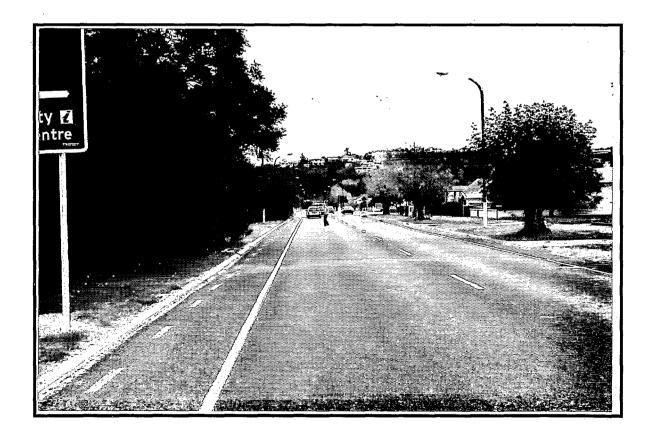
Photograph B8 The traffic signals at the intersection in the back ground (by the cars) are hidden from approaching drivers by vegetation.
